Klark Teknik DN360 : Common Problems

The two most common problems in the Klark Teknik DN360 graphic equaliser are due to (1) oxidation on the connectors between the fader panel and the electronics, the most common symptom will be selected EQ bands not functioning (2) cracked solder joints on the XLR input/output PCB near the XLR connectors, the most common symptom will be intermittent level changes between input and outputs.

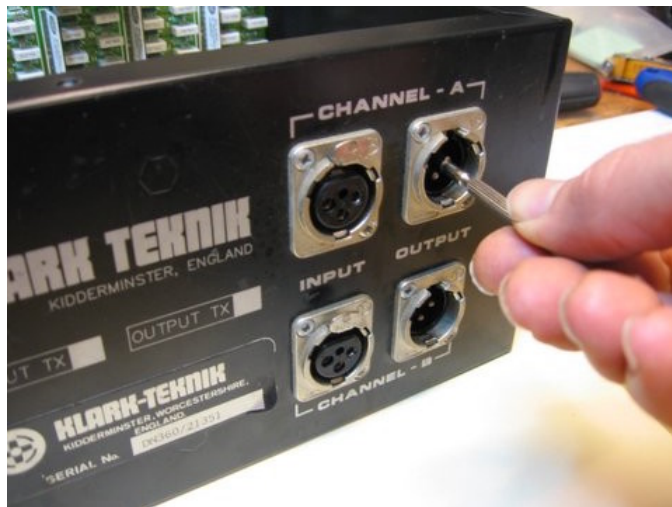
The underside of the XLR input/output PCB will need partial re-soldering.

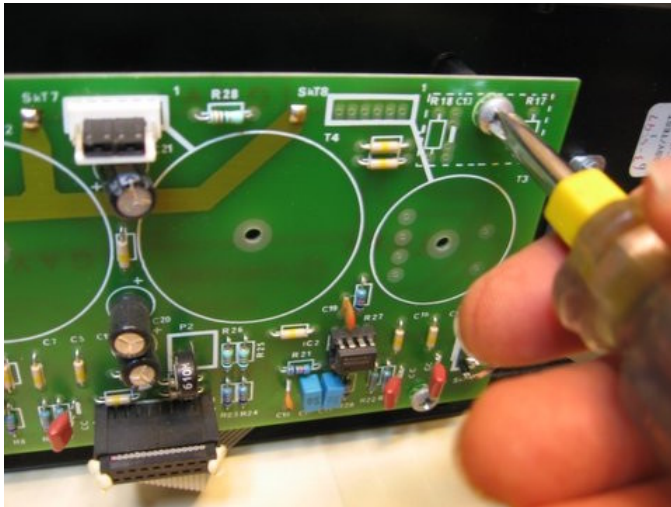
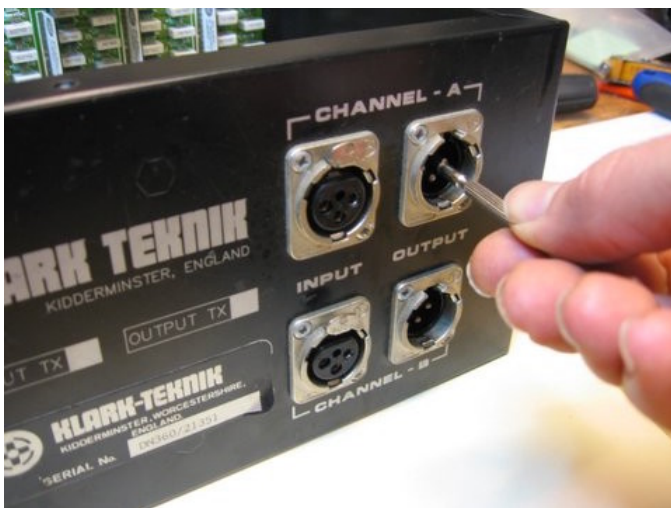
Cracked Solder Joints on the XLR Input/Output PCB

Re-solder the bypass relays and anything suspect looking in the area. Only use good quality standard 60/40 solder. Pay particular attention to the pins that connect the top side of the circuit board to the bottom side.
